**Name:** Abby Cottier

**Date:** 12/2/24

**Object:** Bonnie Cashin skirt using fabric designed by Dorothy Liebes

**Accession #:** F.2016.86

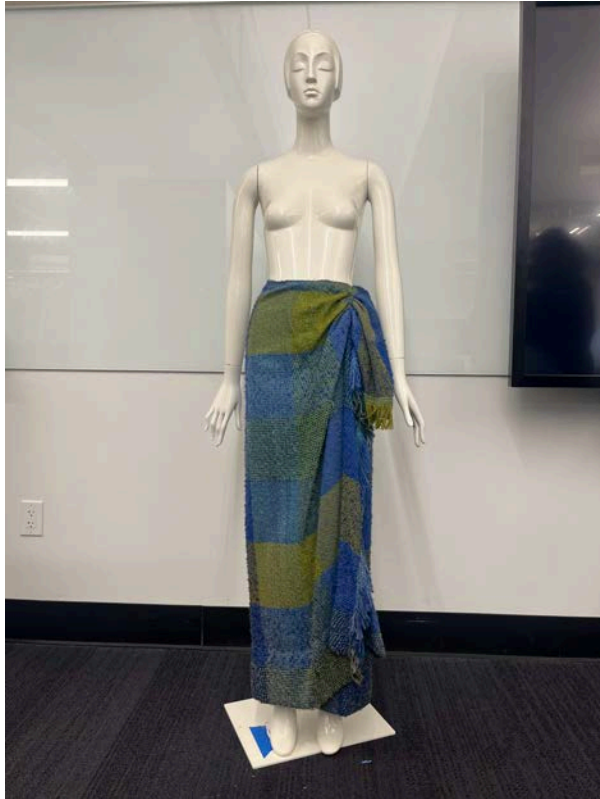
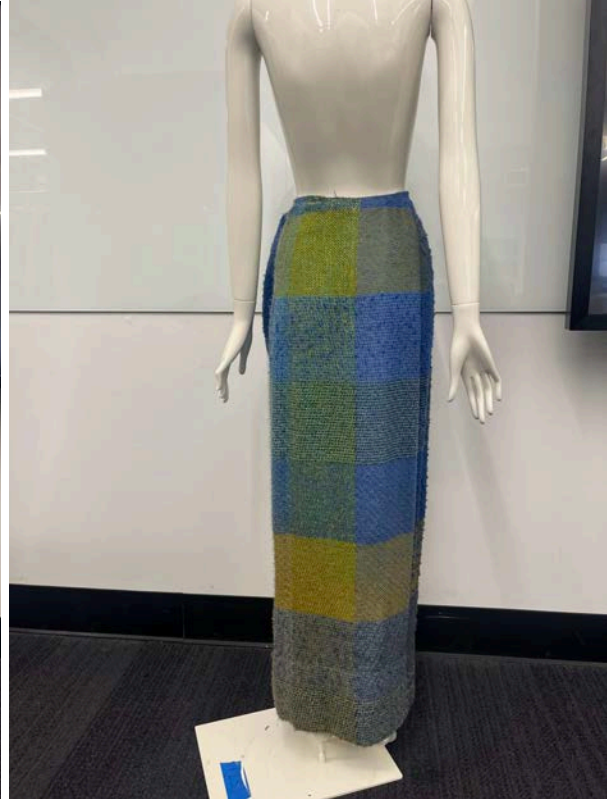
Front and back of skirt, mounted.

**Overall Condition:** Good. Some pulling of bouclé yarns as well as abrasion on the outer side of the fabric causing minor pilling. One of the closures is missing a hook. Some discoloration (soiling or possible dye fade) on the back of the skirt near the hem. Otherwise, the skirt looks very good and is structurally sound.

**Necessary Treatment:** Inside and outside of skirt should be vacuumed. Part of waistband should be humidified to flatten creased petersham ribbon. Missing hook at front wrap closure should be replaced.

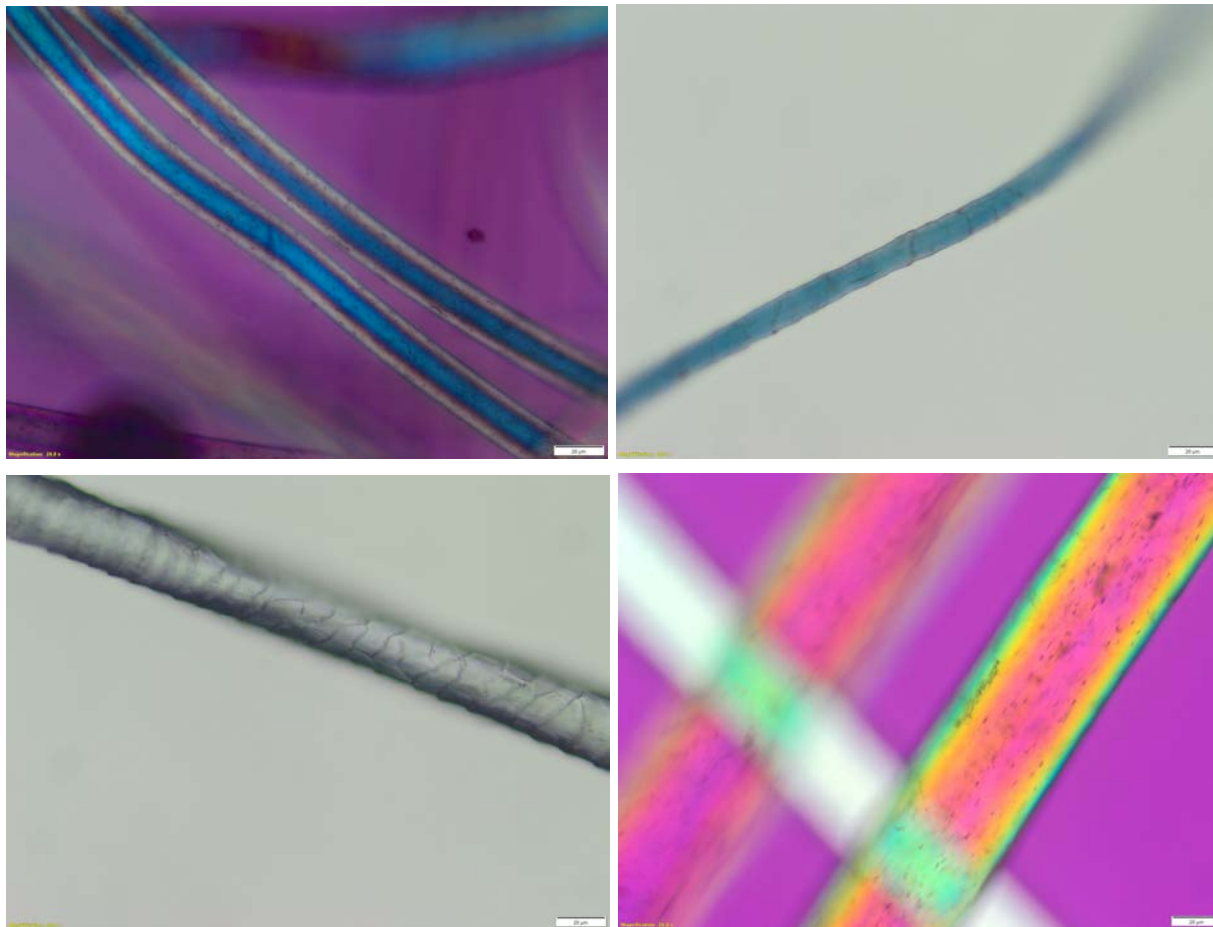
Wool and nylon fibers in main fabric.

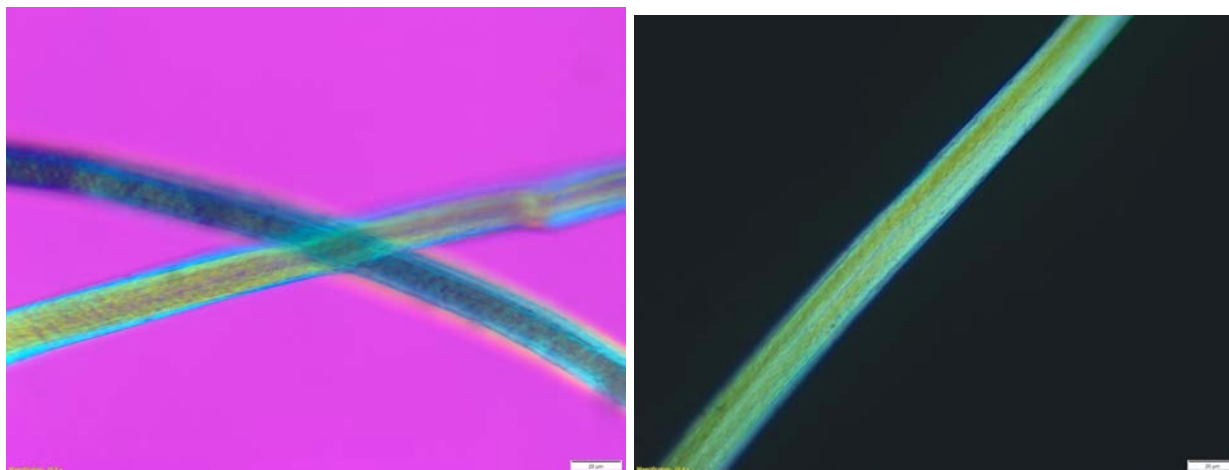
Viscose rayon petersham ribbon fibers.

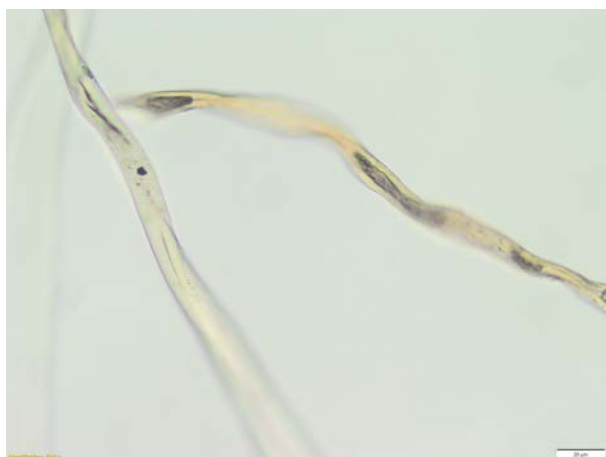
Mercerized cotton fibers in sewing thread.
